“TAKE GOOD CARE OF YOUR FEEDWATER HEATERS”

Powerfect, Inc.

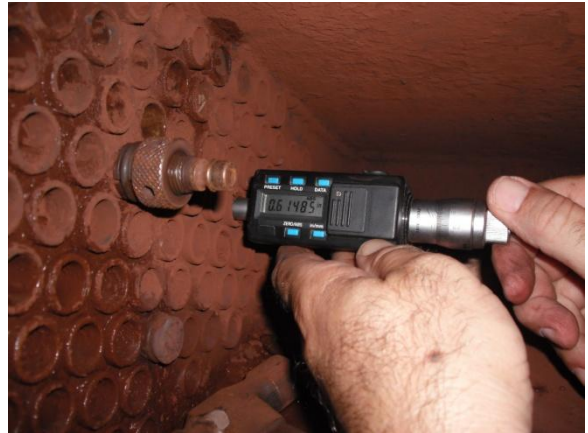
Figure 4 - Measuring inlet tube ID profiles for signs of inlet end erosion

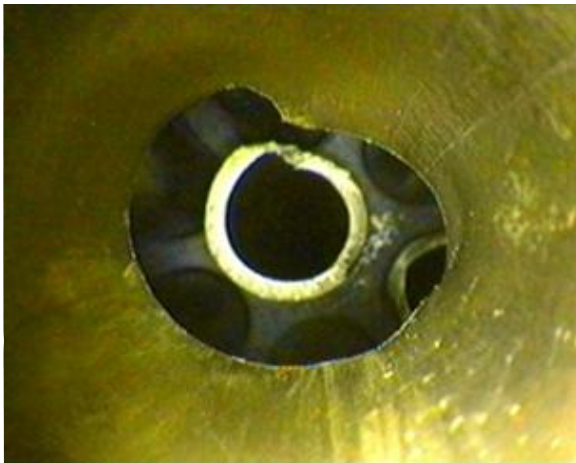
Figure 5 - Severed tube discovered by tube side video probe

The best way to get a look at the inaccessible internals of the FWH is through the use of fiber optic video probes. Probes may be introduced down the tube ID to locate and get a first-hand look at tube failures and characterize the nature of the failure (i.e. is the failure a crack in the tube, a hole, or is the tube completely severed). Additionally, video probes can be introduced through nearby available shell side connections to try to determine sources and extent of failed/damaged areas.

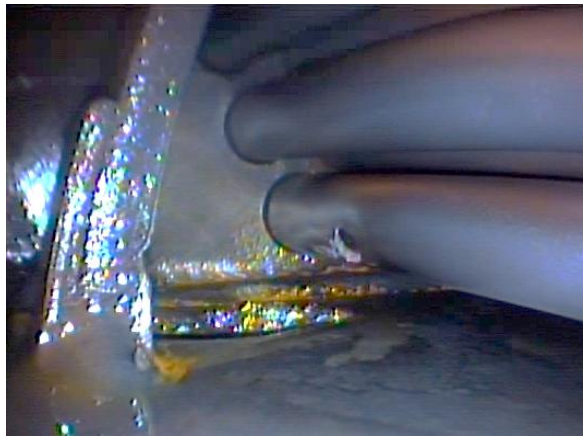
Figure 6 -Shell side video probe of Desuperheating (DSH) Zone inlet window shows damage to bottom plate as well as tube failure.

In figure 6, impingement damage of the DSH zone bottom plate from the adjacent tube failure can be seen. This illustrates the importance of removing leaking heaters from service as soon as practical after a leak is detected. The secondary failures caused by the leak can become more damaging than the initial mechanism.

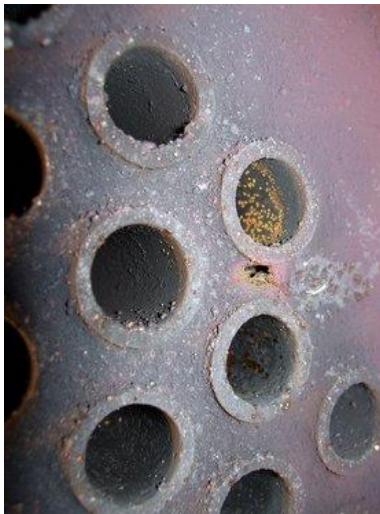
Figure 7 - Tube-to-tubesheet joint weld failure

In order to identify the leaking tube location, the heater should be subjected to a shell side pressure test. This can be done a number of ways; the most common involves filling the shell side with water or pressurizing the shell with air and checking the face of the tubesheet for leaking tubes. The advantage of the shell side leak test is 1) it is much easier to identify the leaking tubes and 2) existing tube plugs in failed tubes can also be tested to ensure they are holding. When the shell is pressurized with air, a soap bubble solution can be applied to the tubesheet to quickly identify leaks. It is important to distinguish between tube failures and tube-to-tubesheet joint leaks. The approach to the repairs (plugging) are predicated on this discovery.

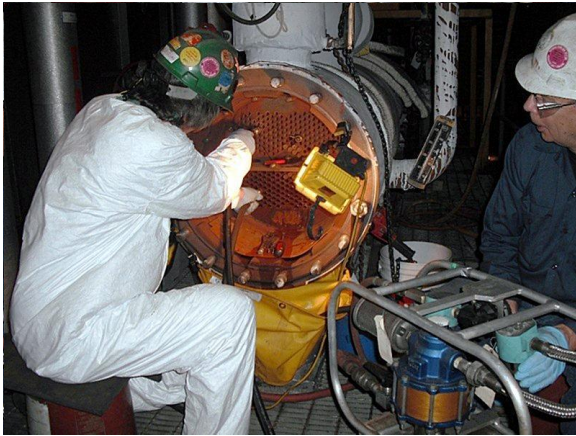
Figure 9 - Individual Tube Hydrotesting System

Once a tube failure is confirmed, some utilities will insurance plug the six tubes surrounding the failure in order to prevent another forced outage in case one of the adjacent tubes had been weakened due to leak impingement. This tends to dramatically increase the percentage of tubes plugged in the heater (often a criteria for heater replacement). This can also result in localized hot spots in the tubesheet where there is no longer feedwater flow, which may cause additional damage or failure of weld repairs. An individual tube hydrotest of the surrounding tubes can prevent the need for insurance plugging by testing each tube to a much higher pressure than the FW operating pressure. Any weakened tubes on the verge of failure will not pass this go/no-go integrity test and will be plugged. Tubes that pass the test can be returned to operation with a high level of confidence.

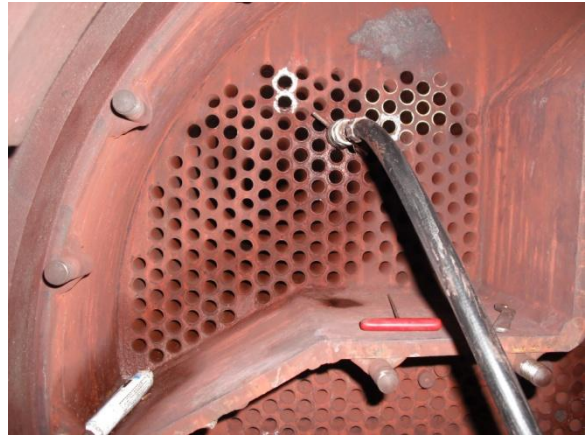
Figure 10 - Hydrotesting an individual tube to high pressure

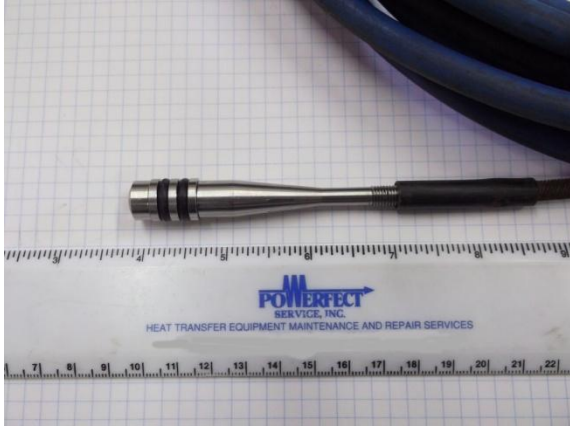
Figure 11 - Probe with rubber seals for tube leak location detection

The location of a tube failure can be quickly determined by a number of methods. Probably the easiest method is by using a video probe to locate the failure and then measuring the length of probe inserted into the tube. Another method is to introduce compressed air into the failed tube from one end, and then insert a tight fitting rod or probe down the opposite end until the leak is covered, at which point the pressure in the tube will increase. The length of rod inserted will give the location of the leak. In vertical channel down heaters, the manometer principle can be employed using clear plastic tubing coupled to the failed tube leg.

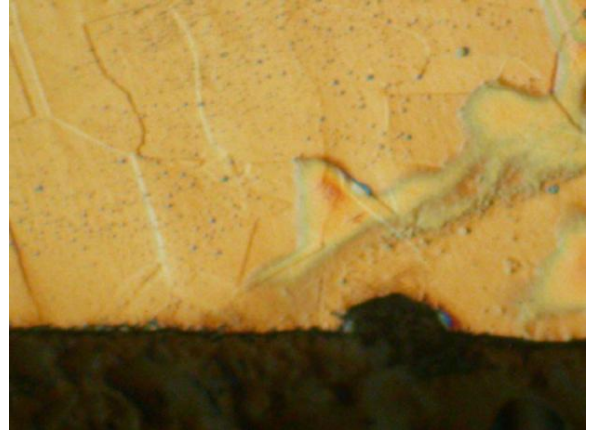
Figure 14 - Tube Defect viewed under microscope

Following ECT or a tube failure, the best way to get a first-hand look at the nature of the defect is through tube sampling. Pulling a tube section from the heater has several advantages; 1) the defect can be viewed visually or under a microscope, 2) it can be used to confirm the credibility and reliability of the ECT results and 3) the tube can be sent to a metallurgical lab in order to identify suspected failure mechanisms. When sending a tube sample to a third-party laboratory, the Utility should provide certain background data to the lab such as material compositions, typical pressures and temperatures experienced, and typical water chemistry. A good lab should be able to provide useful information such as photo micrographs, chemical and metallurgical analysis and provide likely failure and/or corrosion mechanisms.
