## “Individual Tube Hydrotesting Verifies Heat Exchanger Tube Integrity”

Mike Catapano  
President  
Powerfect, Inc.

Eric Svensson  
Vice President – Engineering  
Powerfect, Inc.

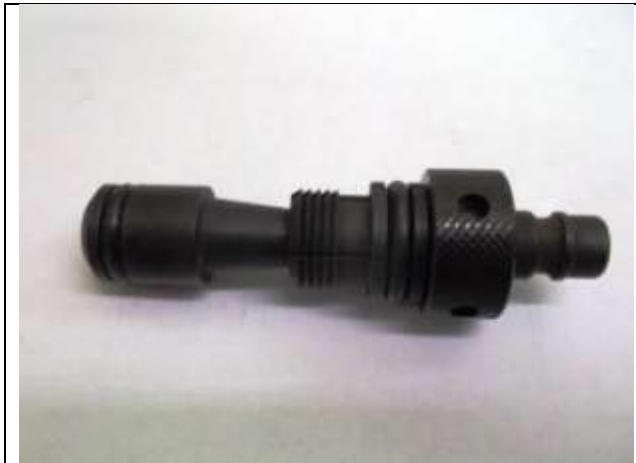
Figure 1 – Powerfect Individual Tube Hydrostatic Test Plug

The development of an individual tube hydrotesting system used with test plugs that gripped and sealed the tubes from the internal diameter became a preferred alternative to insurance plugging. ITHT of the surrounding tubes can prevent the need for insurance plugging by testing each tube to a much higher pressure than the feedwater tube side operating pressure. Any weakened tubes

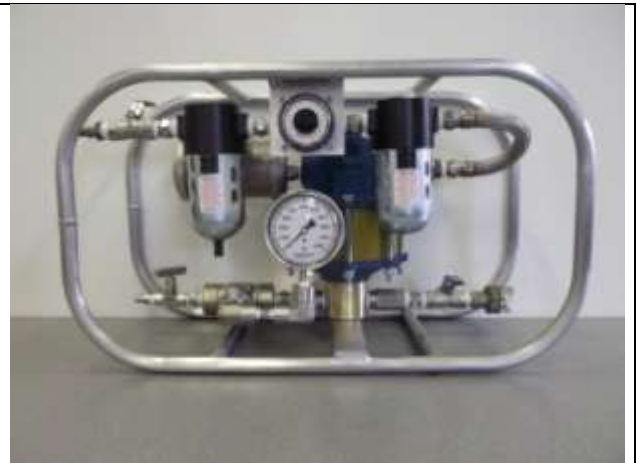
Figure 2 – Powerfect Portable Individual Tube Hydrostatic Tester

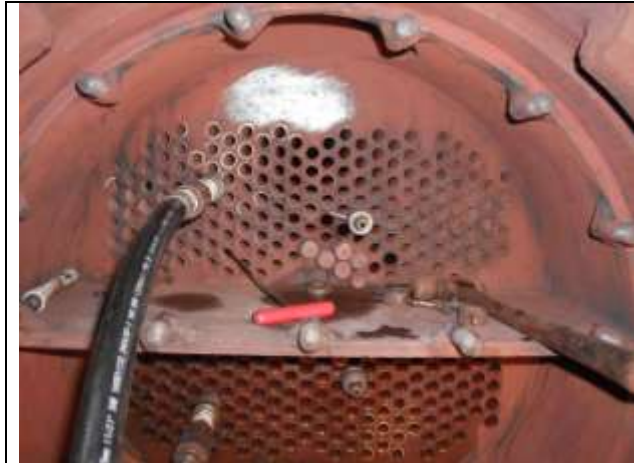
Figure 3 – Testing a FWH with ITHT.

Tubes may be individually tested in order to provide a go-no/go test to determine whether the tube is failed or weakened and on the verge of failure. By treating each tube as an individual pressure vessel, the tube can be tested to pressure higher than the tubeside operating and design pressures as per UG-27 of the ASME Boiler and Pressure Vessel Code, Section VIII, Division 1, which gives equations for calculating the maximum allowable working pressure (MAWP). UG - 99 of the current Code prescribes the 1.3 multiplier times the MAWP for the allowable hydrotest pressure.

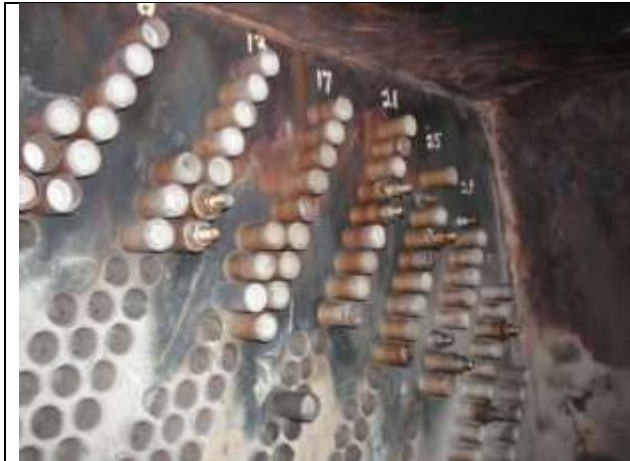
Figure 6 – Condenser Tube plugs prior to testing

Over the course of many years, a station plugged a significant number of condenser tubes during short duration outages. Typically, when a forced outage was taken to resolve an apparent condenser leak, the shell side was flooded overnight and the waterboxes were opened. The following morning station mechanics were sent in to find and plug the leak(s). In most cases, water leakage was found cascading down the face of the tube sheet and the actual leak locations were difficult to identify. Many times the tubes that they thought were leaking were plugged along with several other tubes in the surrounding area just to ensure that the leak was stopped. They simply plugged everything they thought may be leaking. Although this allowed the unit to

be returned to service as quickly as possible, this practice resulted in many unfailed tubes being plugged. Additionally, the plugs they were using were unreliable and tended to loosen over time.

A refurbishment program was developed which included removal of older, unreliable tube plugs and individually hydrotesting the plugged tubes to 500 psig. Tubes that failed the ITHT were re-plugged with more reliable mechanical seal plugs, whereas tubes that passed the ITHT were able to be returned to service based on the high amount of confidence that the tube would not fail in operation.

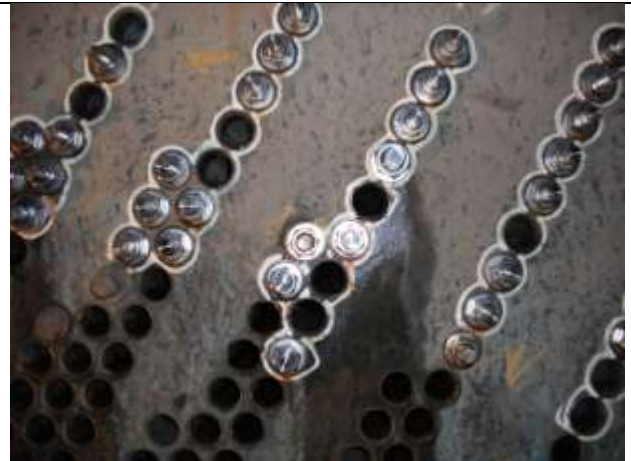
Figure 7 – Condenser tubes following refurbishment. Tubes that passed hydrotest remained unplugged and were returned to service

Overall, the program was deemed to be successful. The improved tube plugs prevented any re-initiation of tube leaks due to loose or dislodged plugs over the course of operations between outages, thereby increasing condenser reliability. In total, 812 tubes out of 1,571 previously plugged (just over 50%) were able to be returned to service, thereby restoring additional surface area in the condenser that was unnecessarily plugged and improving condenser efficiency.
